Final

**PHASE I ENVIRONMENTAL BASELINE SURVEY
PARCELS E2, F, and I, MILITARY HOUSING AREAS
NELLIS AIR FORCE BASE, NEVADA**

September 2011

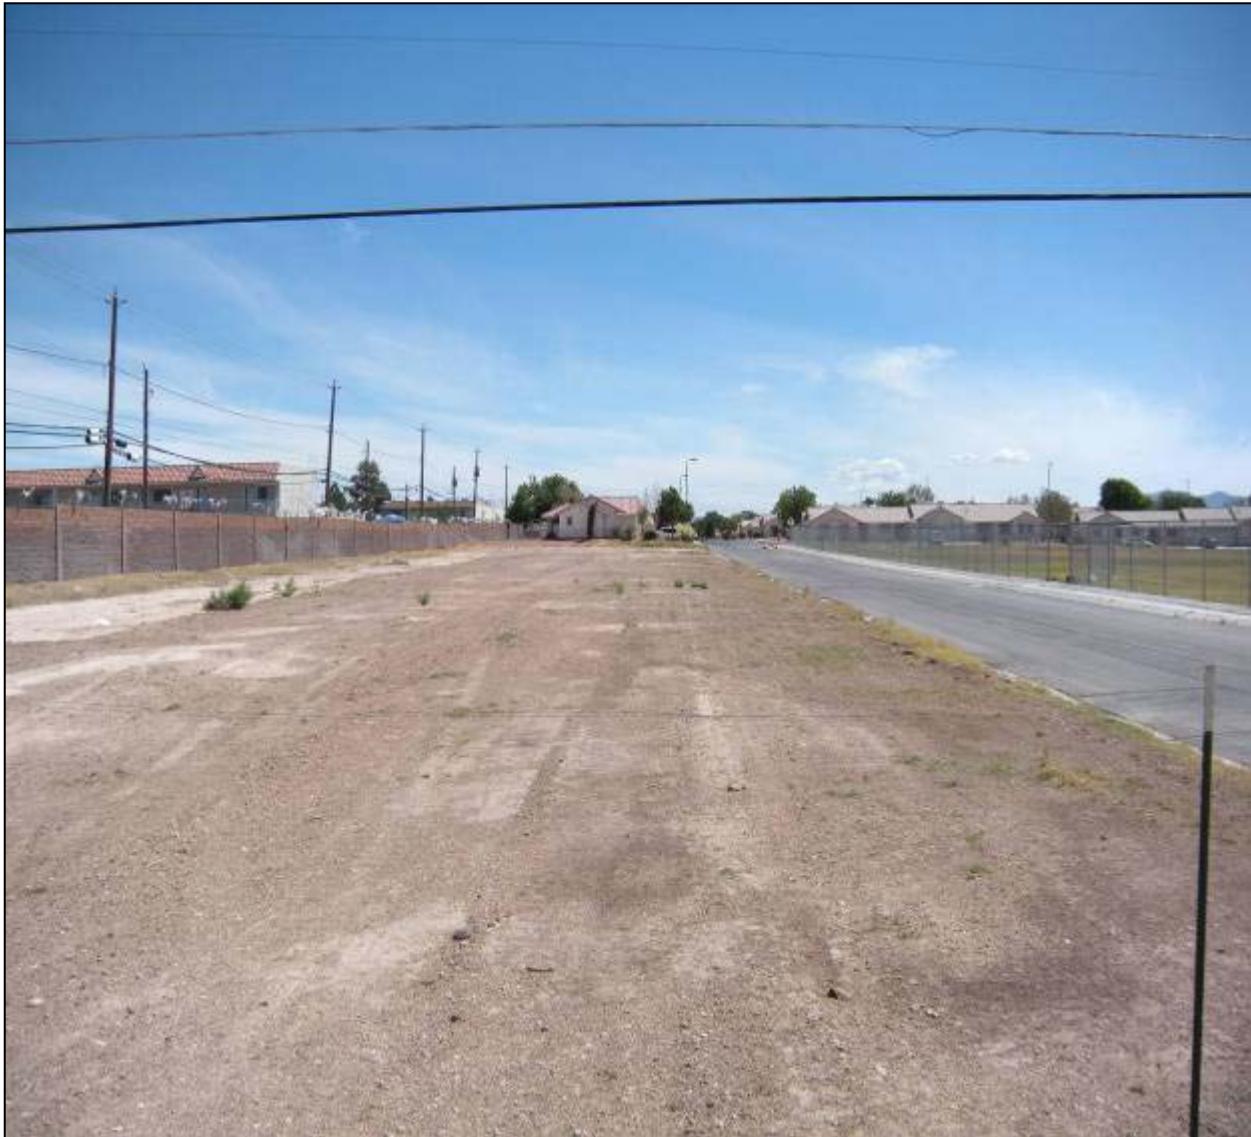
Figure 14, Parcel E2 looking northeast from midpoint along north boundary wall

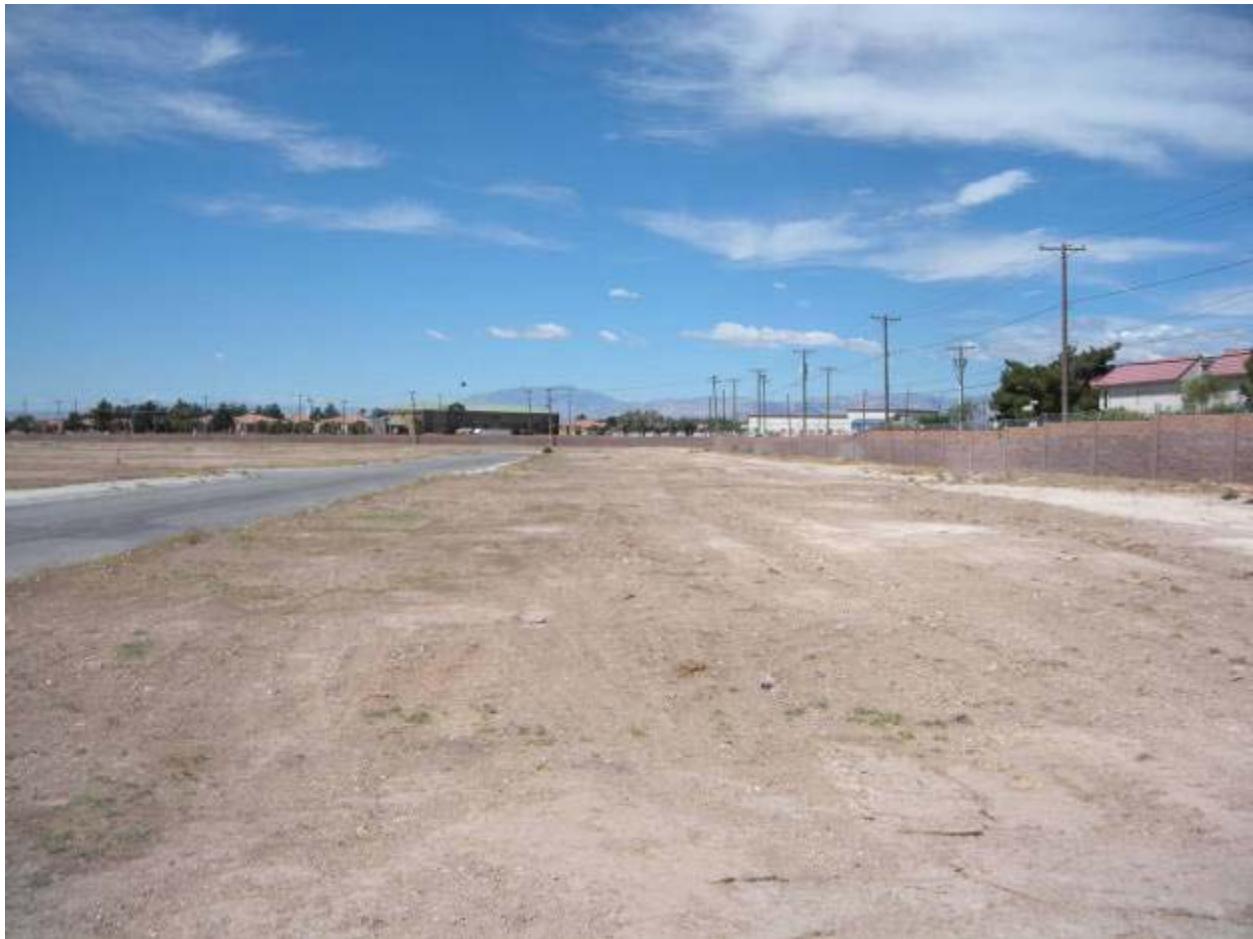
Figure 15, Parcel E2 looking southwest from midpoint along north boundary wall

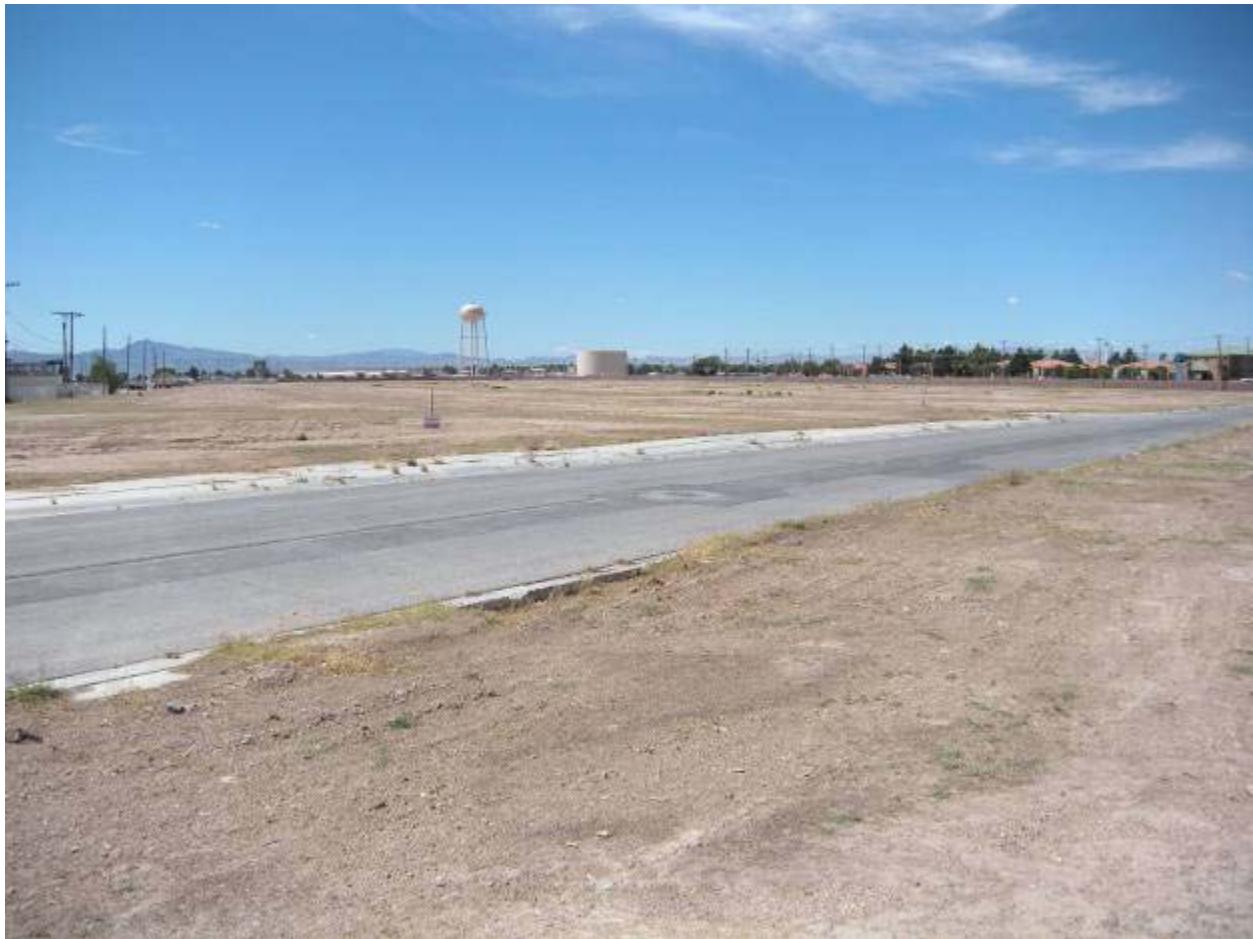
Figure 16, Parcel E2 looking south from midpoint of north boundary wall

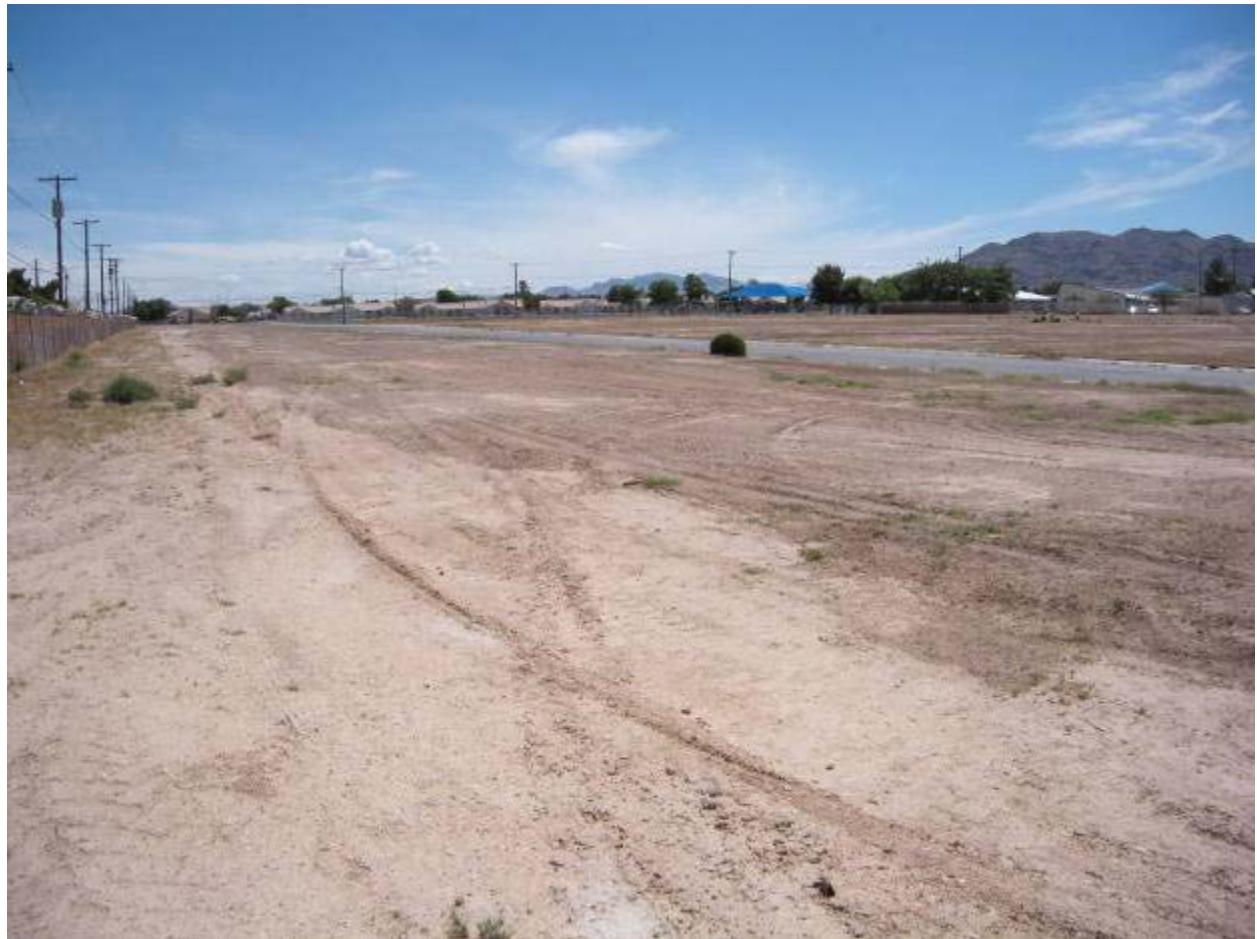
Figure 17, Parcel E2 looking northeast from northwest corner of parcel

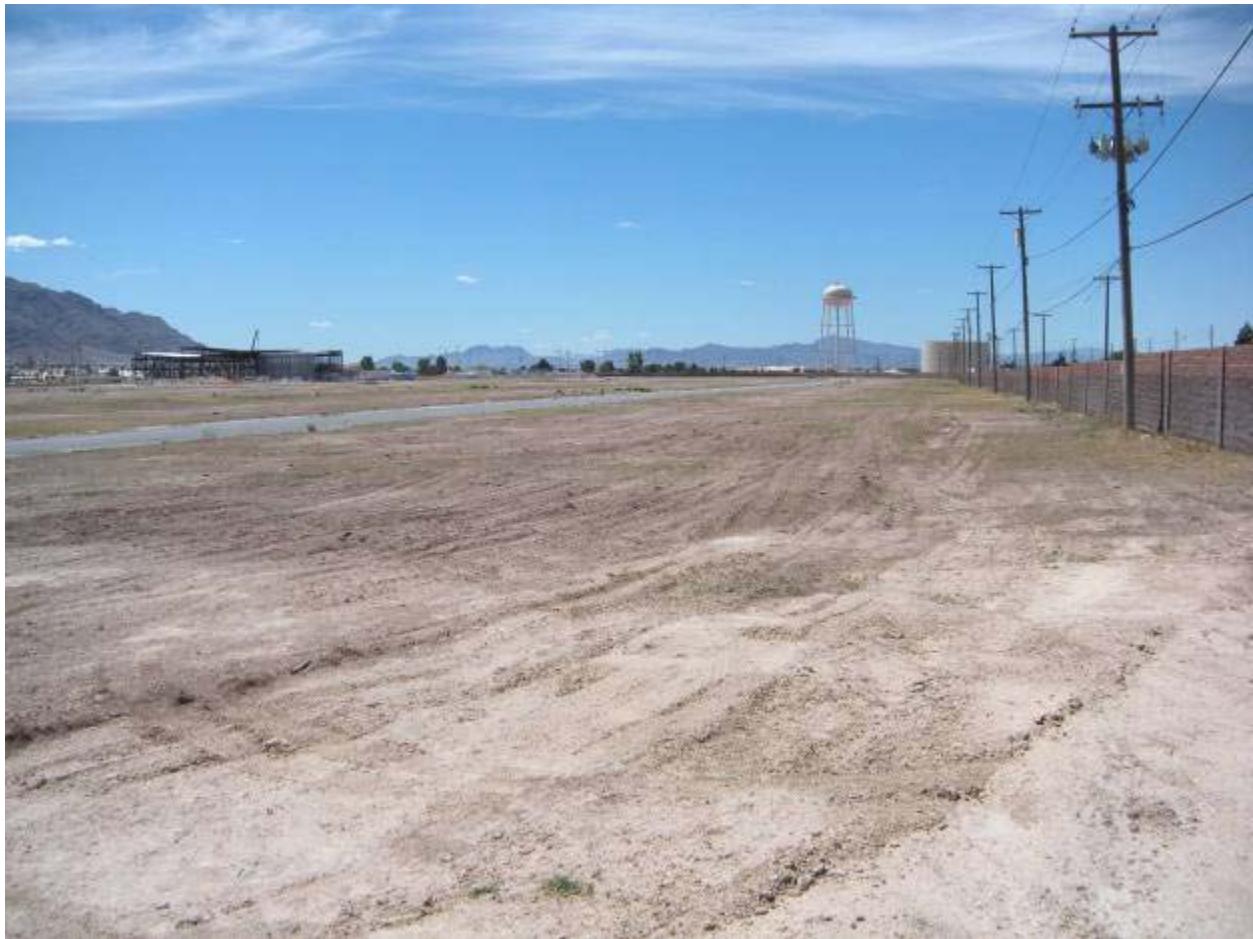
Figure 18, Parcel E2 looking southeast from northwest corner of parcel

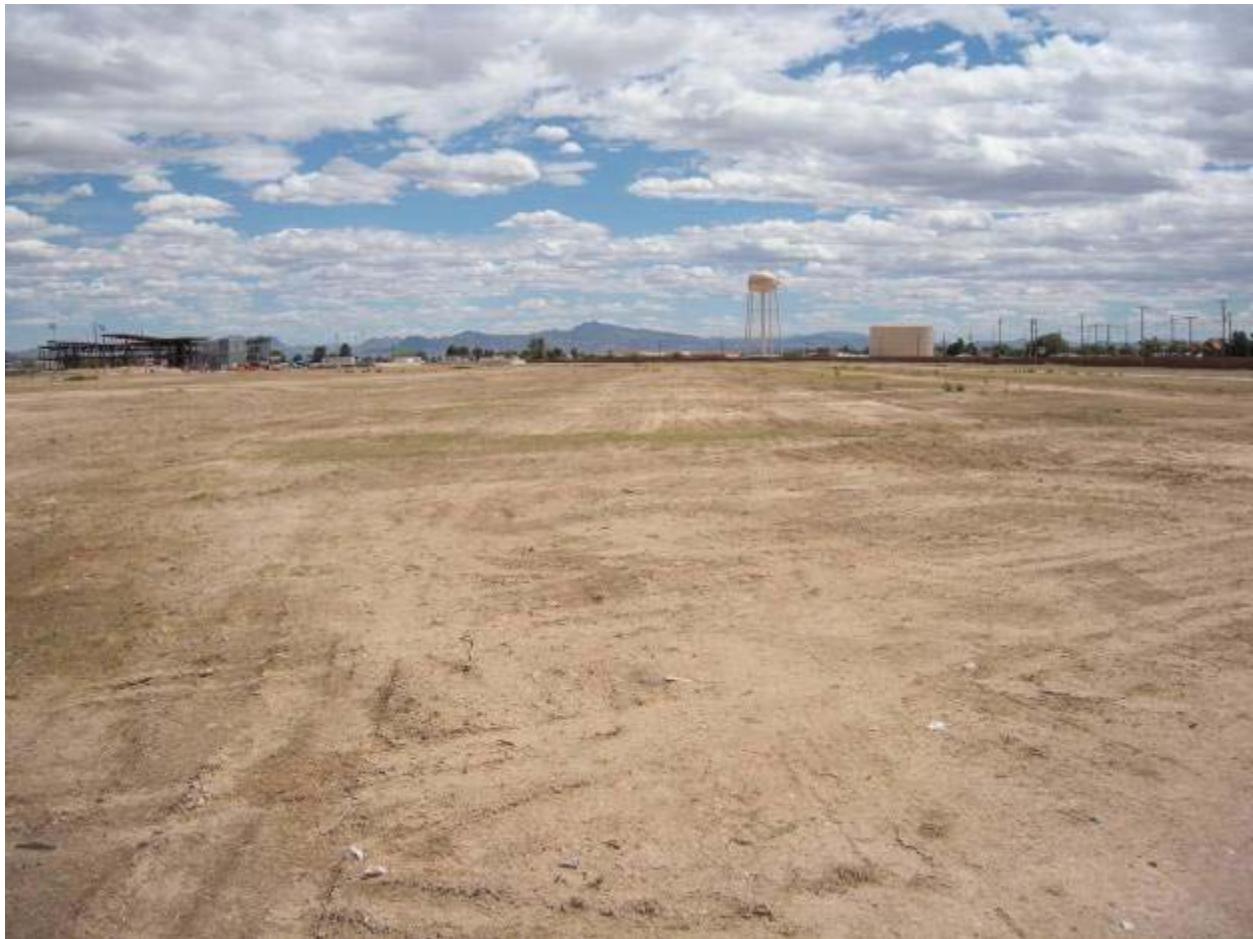
Figure 19, Parcel E2 looking south from center of parcel

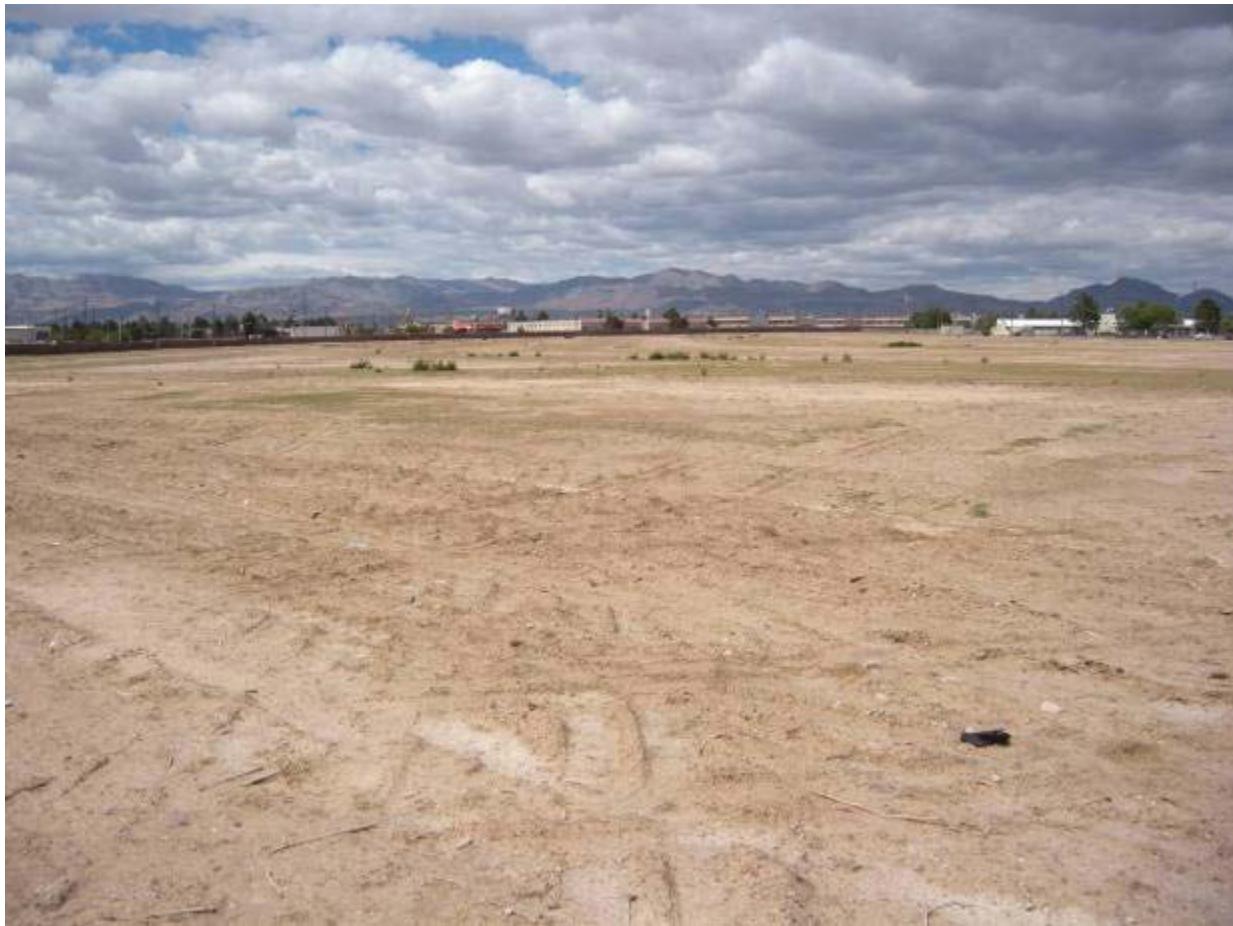
Figure 20, Parcel E2 looking north from center of parcel

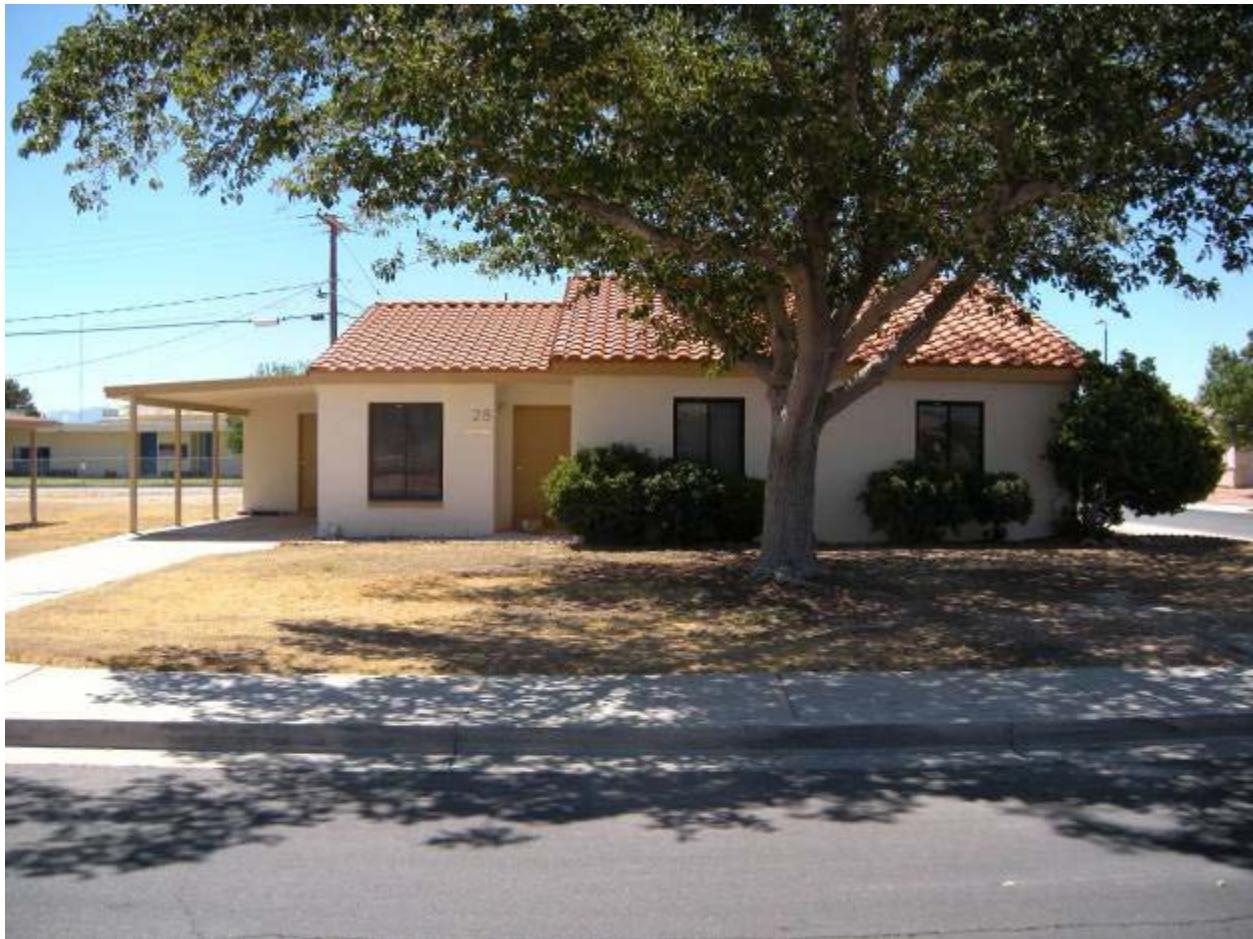
Figure 21, Parcel E2, remaining MFH unit front view

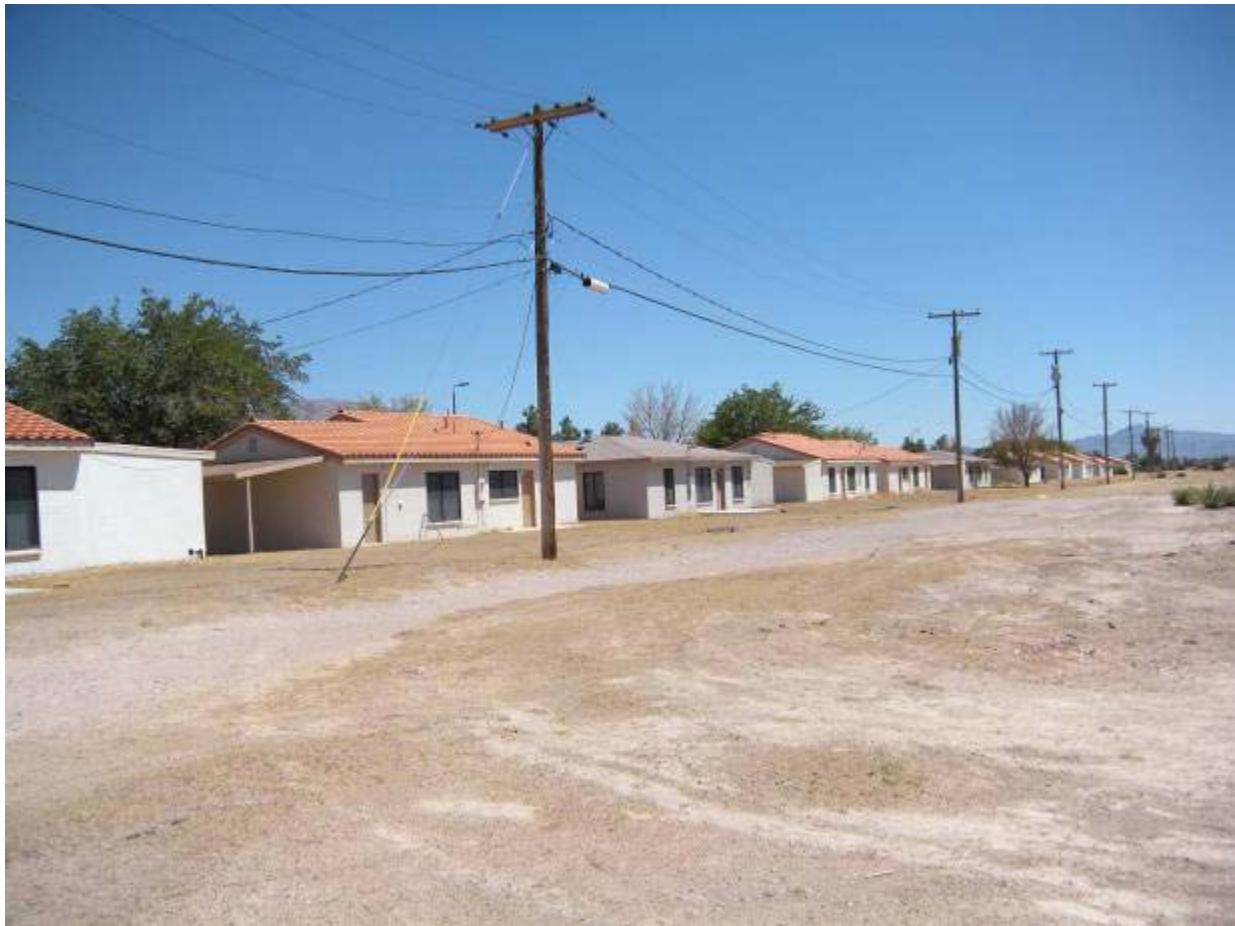
Figure 22, Parcel E2 existing MFH units, rear view

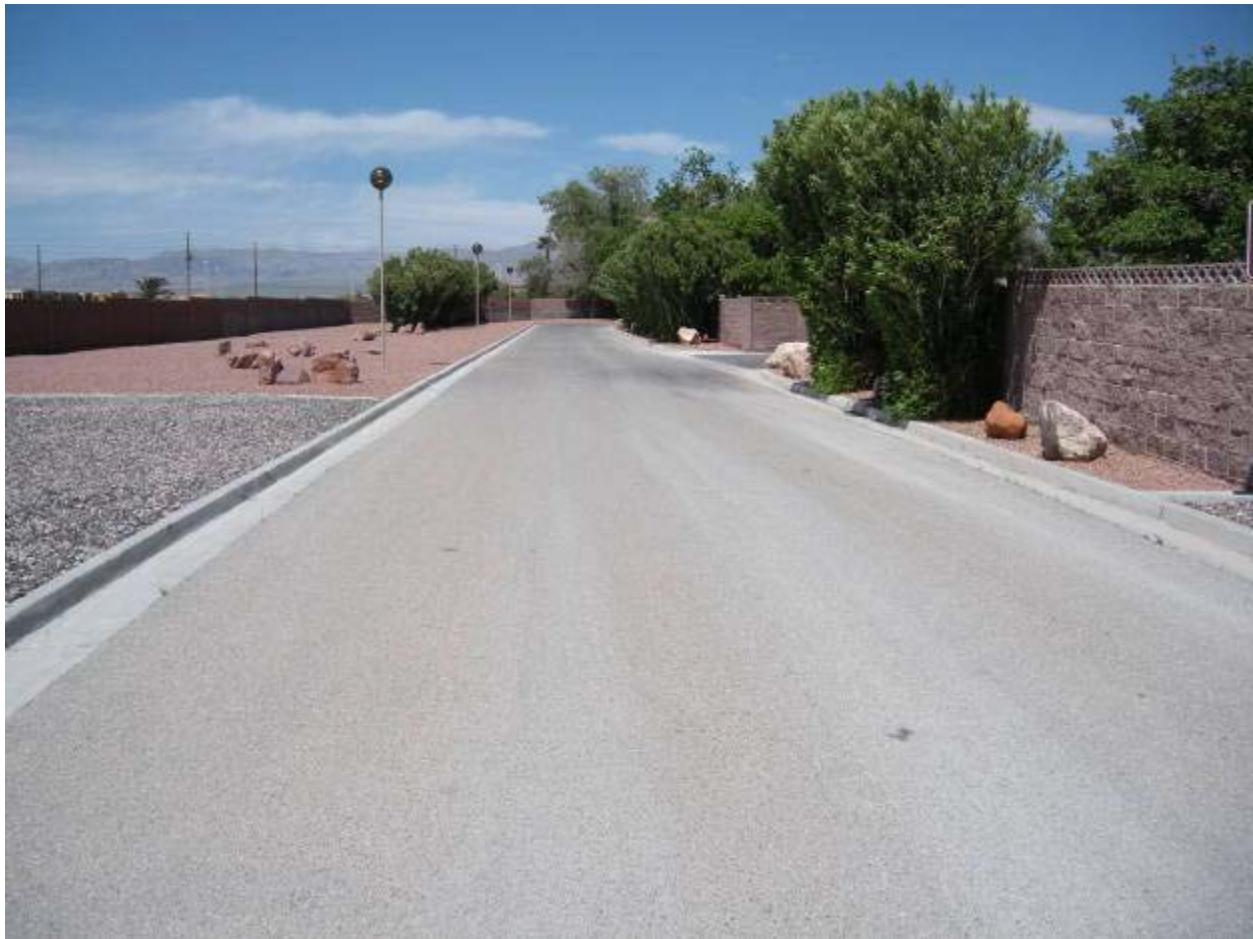
Figure 23, Parcel F, southwest corner looking north up Dunning Circle Drive.

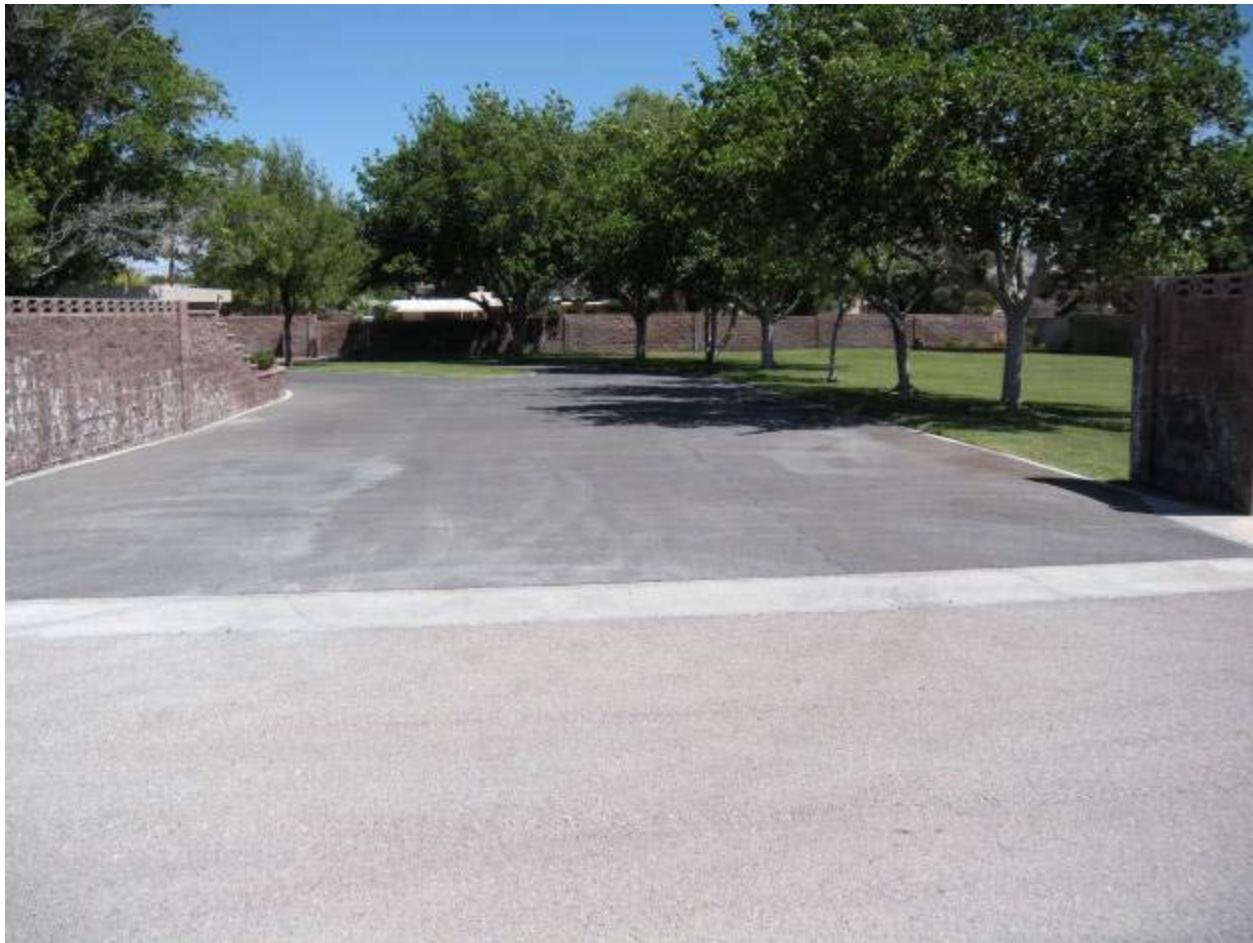
Figure 24, Parcel F, Building 650 driveway

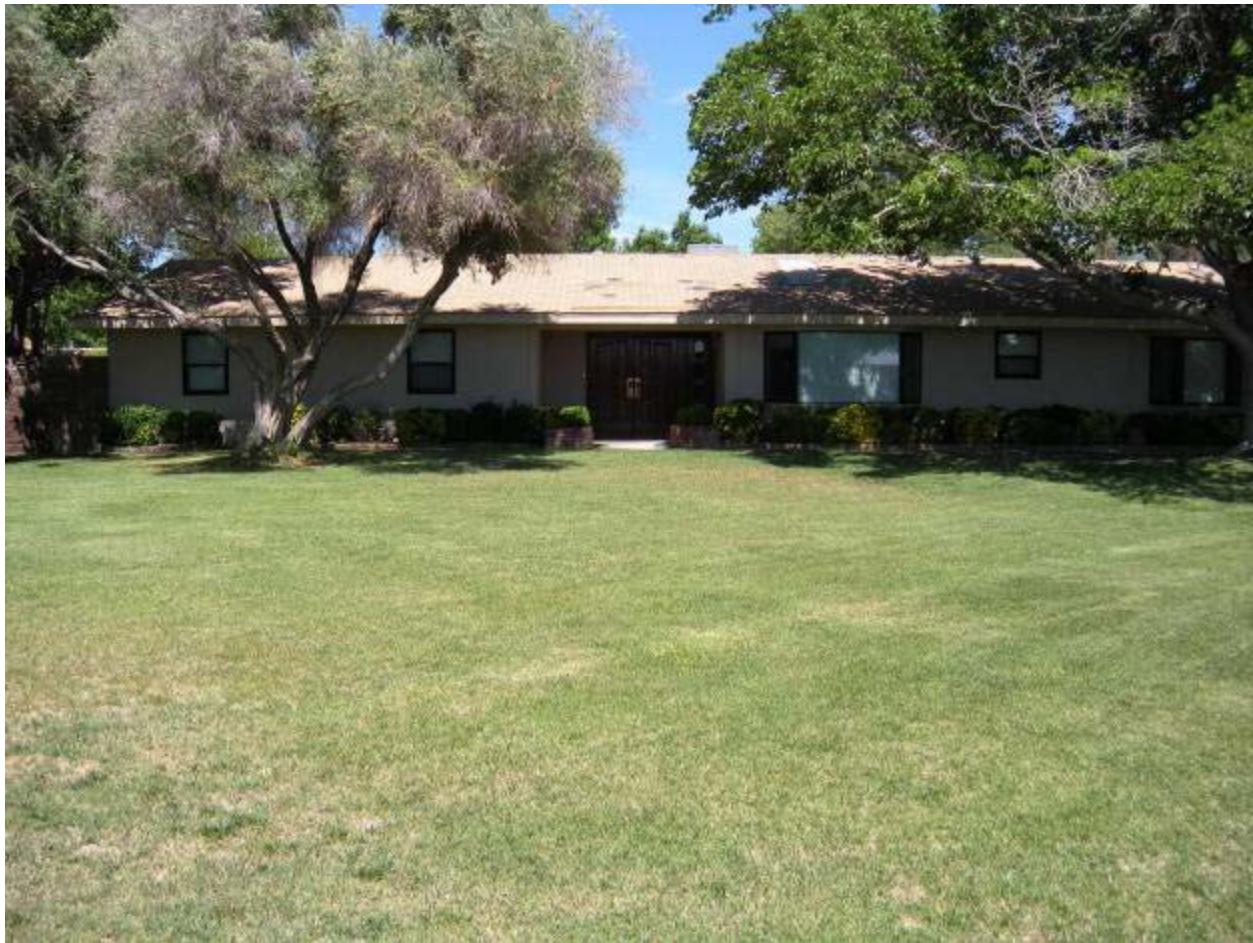
Figure 25, Parcel F, Building 650 front view

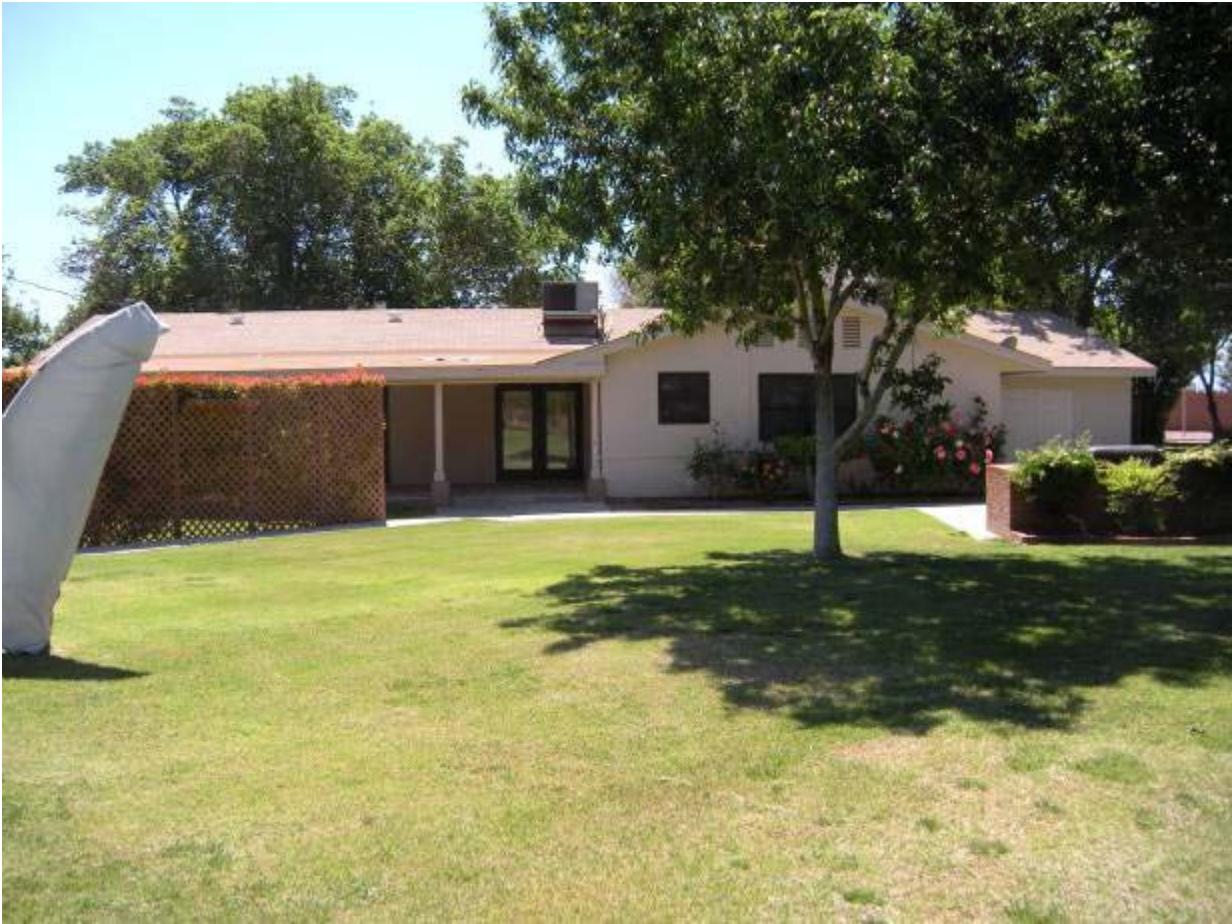
Figure 26, Parcel F, Building 650 rear view

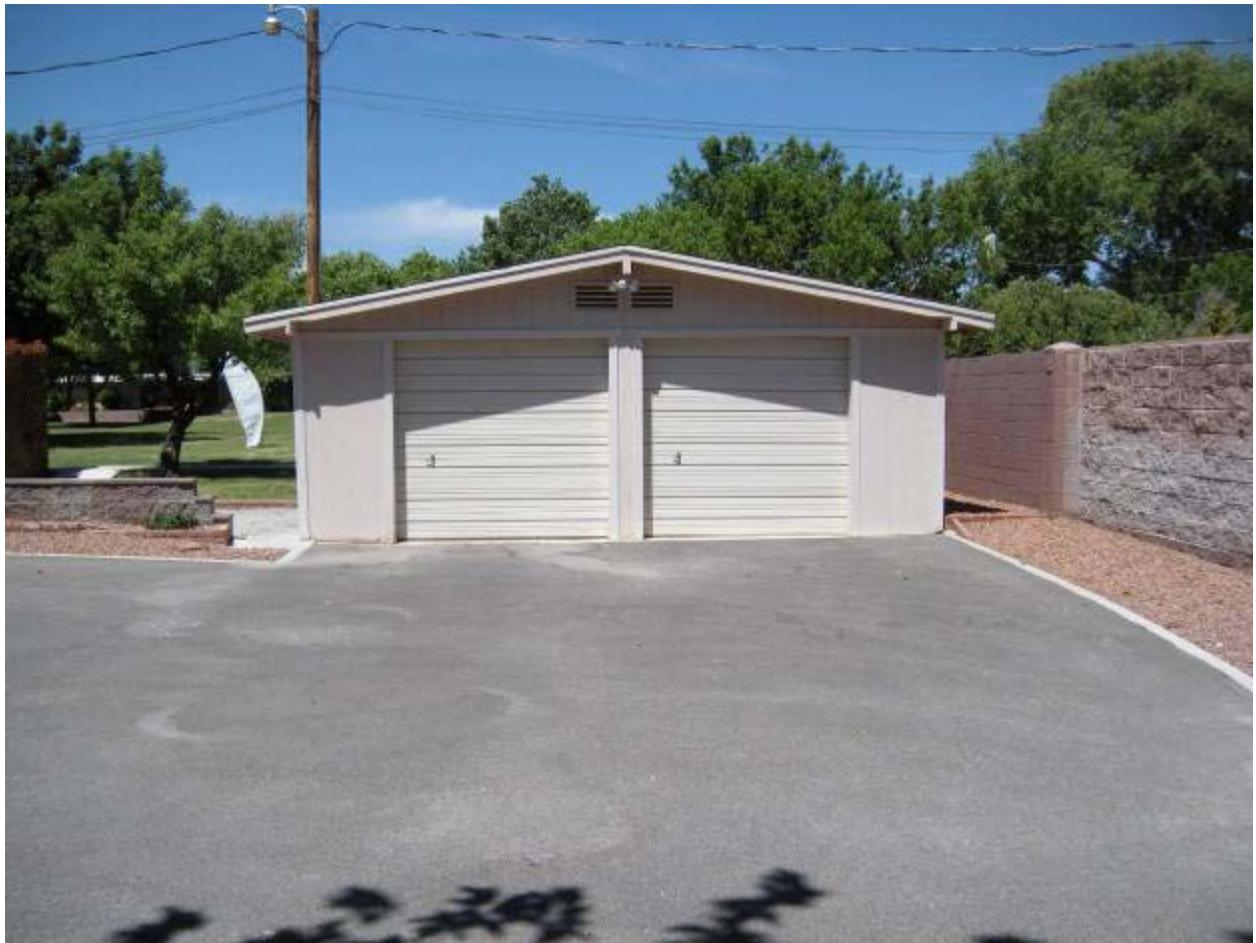
Figure 27, Parcel F, Garage, Building 655

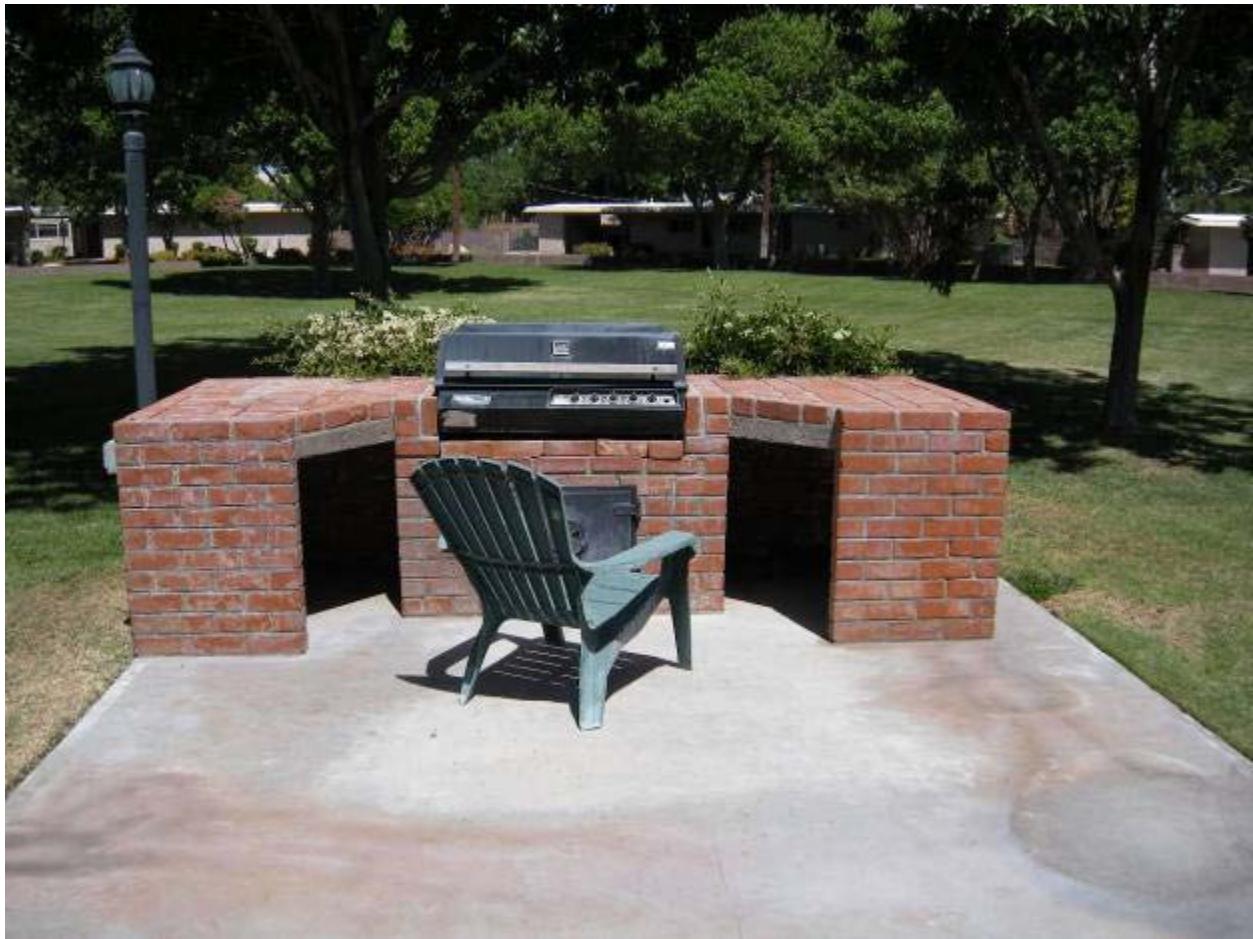
Figure 28, Parcel F, Bar-BQ at rear of Building 650

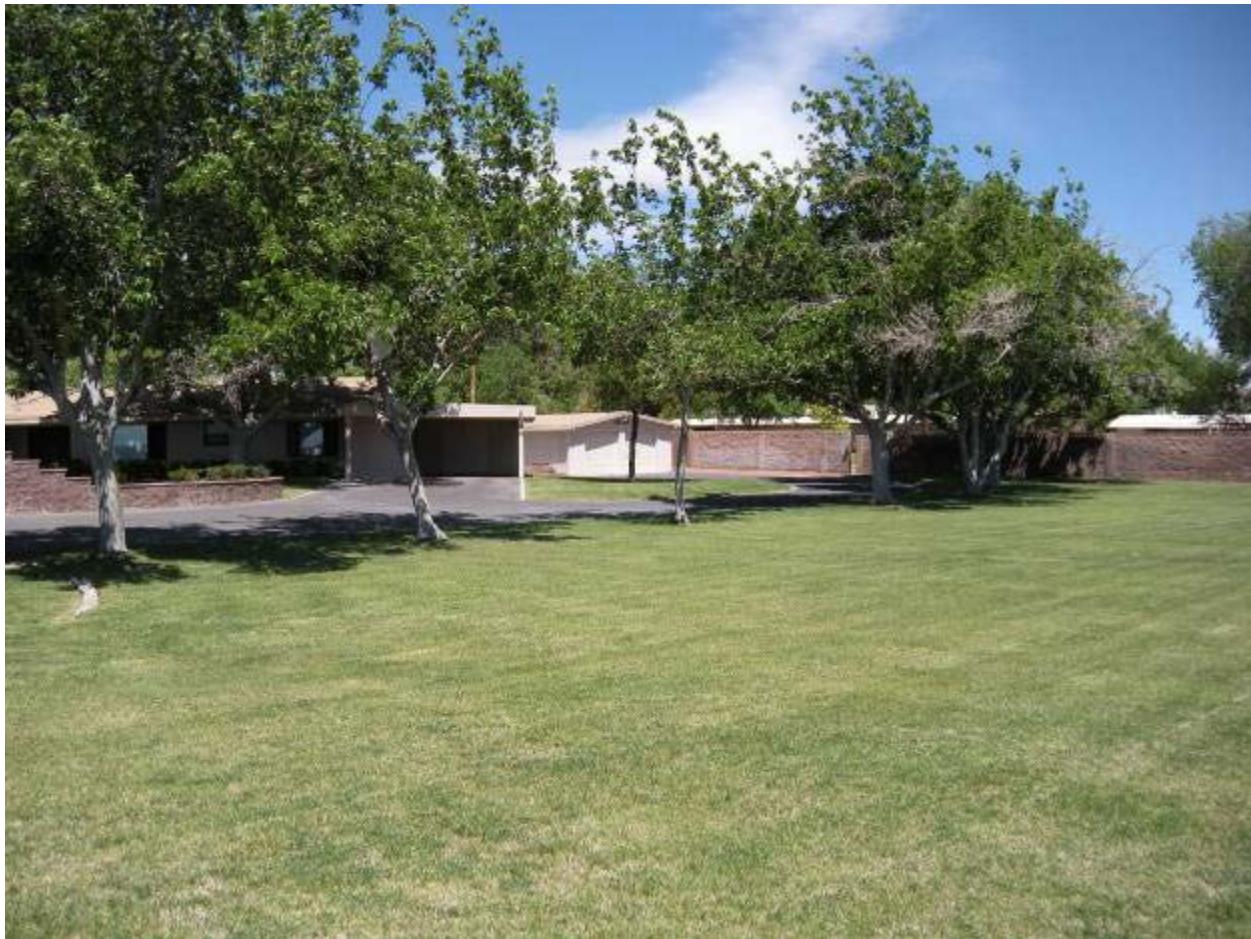
Figure 29, Parcel F, Building 650 front yard

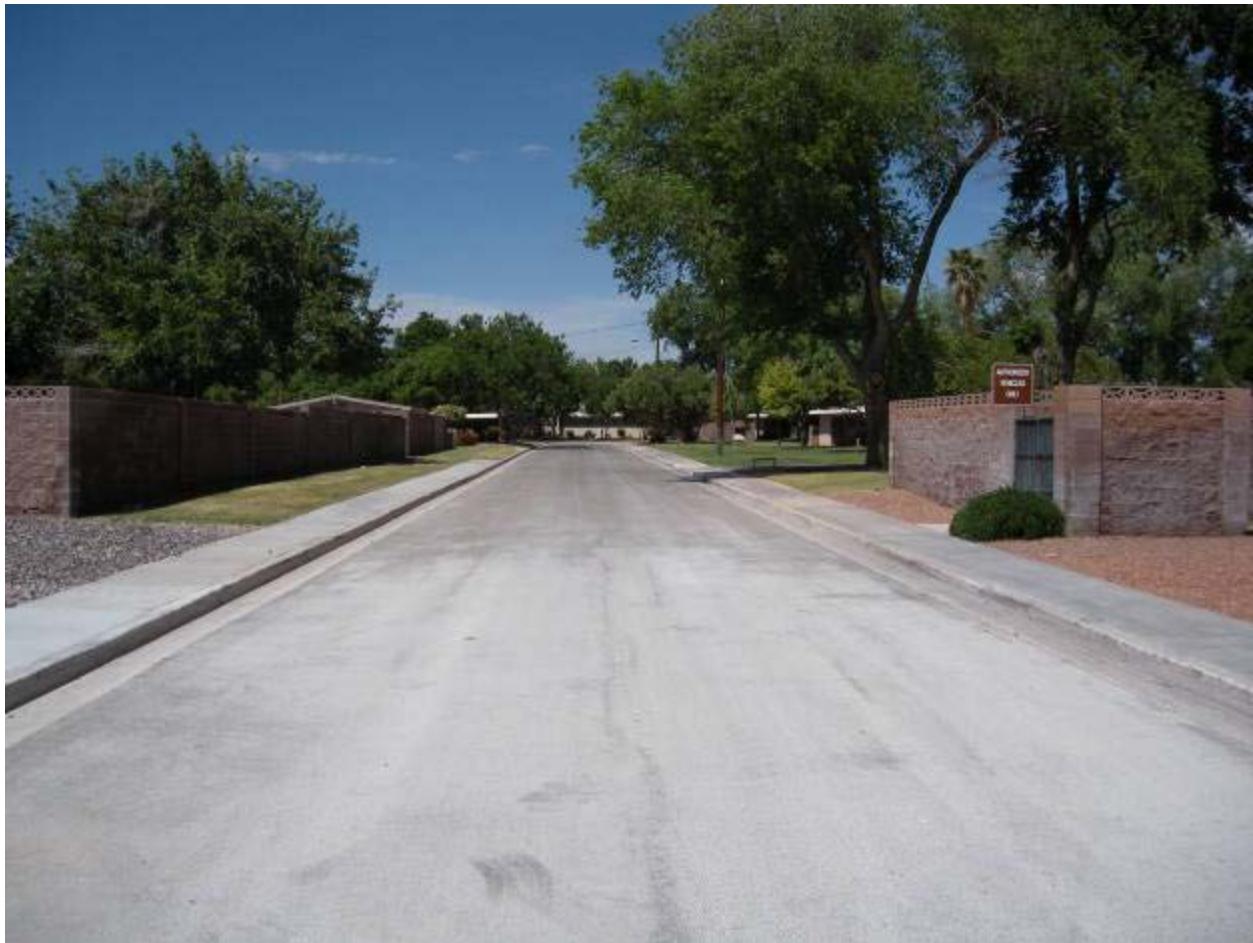
Figure 30, Parcel F, east leg of Dunning Circle Drive looking north

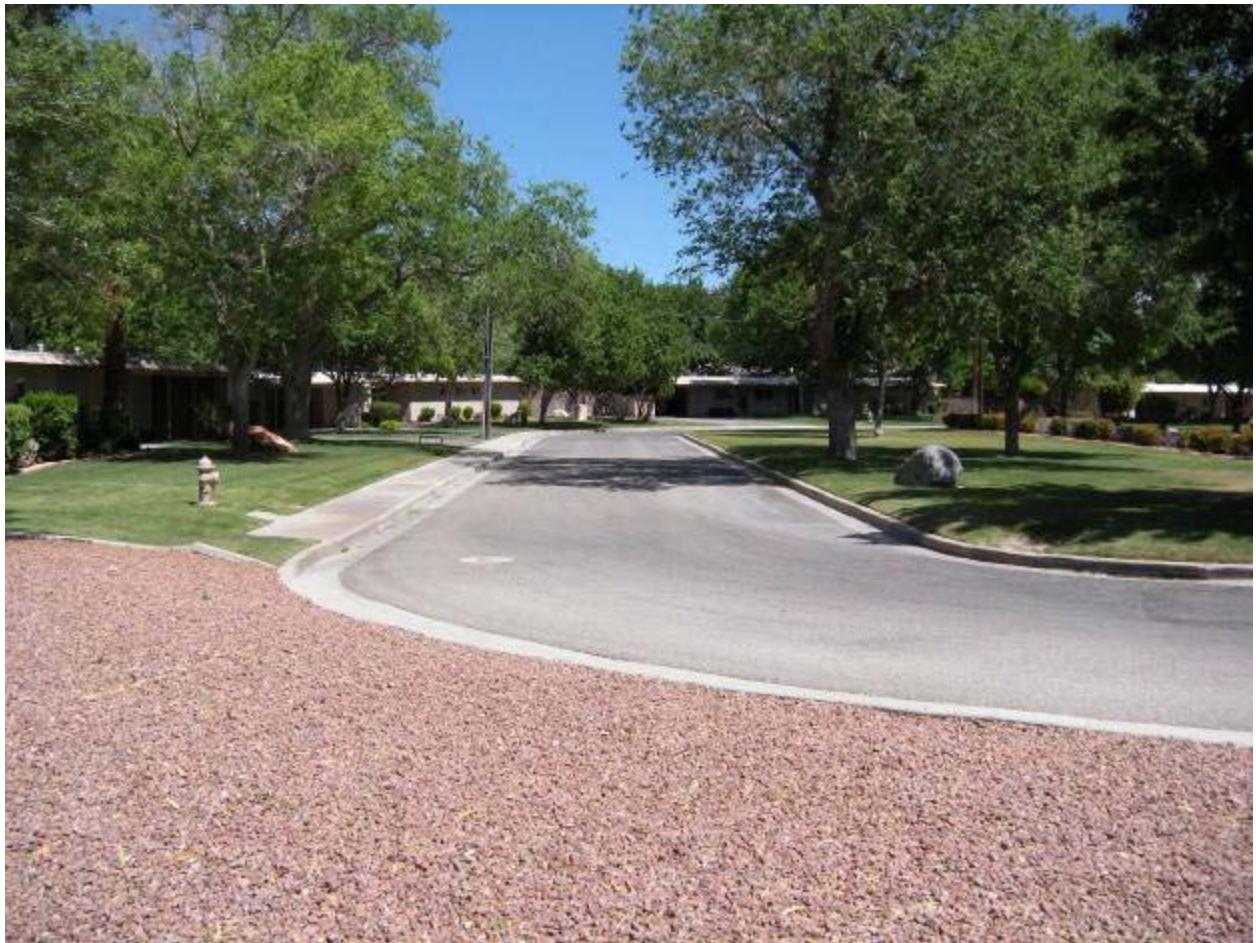
Figure 31, Parcel F, north leg of Dunning Circle Drive looking east

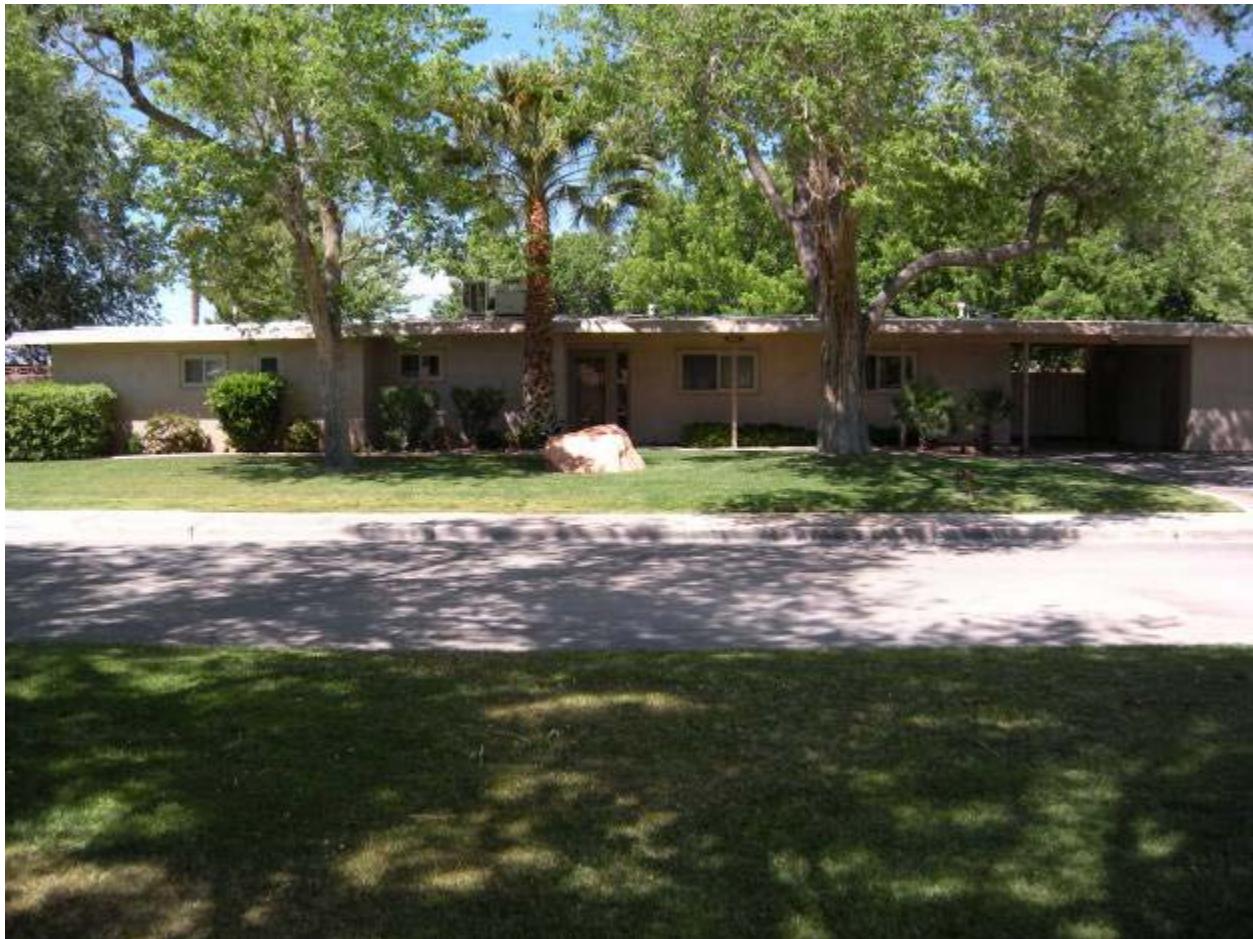
Figure 32, Parcel F, Building 644 front view
